Demonstration Truck Program 7. Field Test of a
Quieted General Motors Brigadier Heavy-Duty
Diesel Truck

Field
Test
of a
Quieted
General Motors
Brigadier
Heavy-Duty
Diesel Truck

Report No. 4796

FIELD TEST OF A QUIETED GMC
BRIGADIER HEAVY-DUTY DIESEL TRUCK

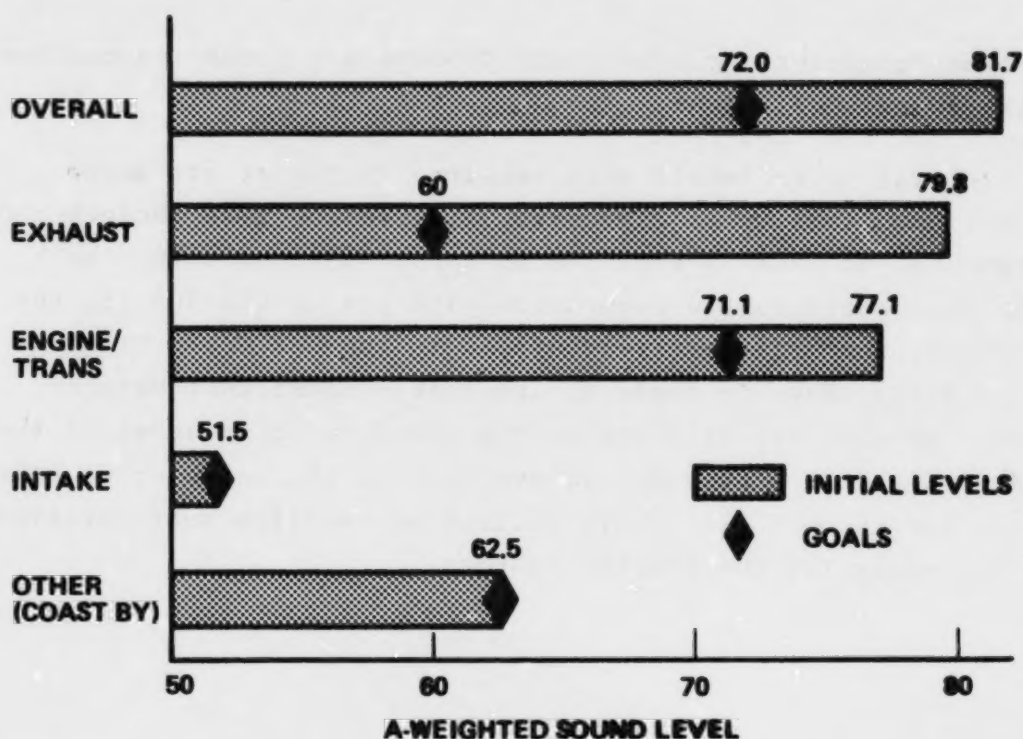
FIG. 2. OVERVIEW OF MAJOR NOISE SOURCE LEVELS AND GOALS.

Initial noise levels were measured by EPA at its Noise Enforcement Facility in Sandusky, Ohio, and by Bolt Beranek and Newman Inc. at Hanscom Field in Bedford, Massachusetts. Both tests were performed in accordance with the 40 CFR 205 [5] test procedure, which is nearly identical to the SAE J366b Standard. The results, shown in Table 2, are fairly consistent between sites. We consider 81.7 dBA as the baseline noise level of the vehicle. Figure 2 provides an overview of the major noise source levels for the vehicle in its initial or baseline configuration and the goals for the treated sources.

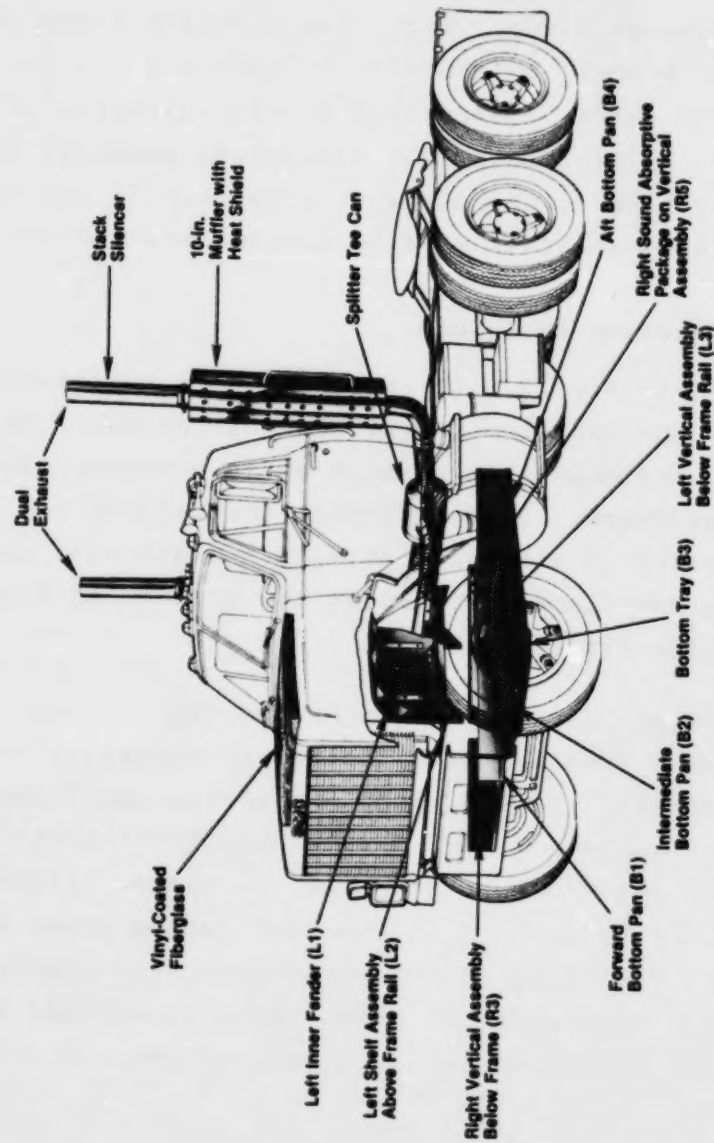
FIG. 3. NOISE CONTROL TREATMENTS INSTALLED ON GMC BRIGADIER.

A dual exhaust system was installed that had three major types of silencing components: a Splitter Tee Can, 10-in.-diameter mufflers, and 4-in.-stack silencers. A 5-in.-diameter

exhaust line, consisting of aluminized steel tubing and stainless steel flex hose, leads from the turbocharger to the Splitter Tee Can. The Tee Can provides some muffling and splits the flow into dual 4-in. exhaust lines. Each line contains a nominal 10-in.-diameter double shell cylindrical muffler and a 4-in. stack silencer. The stack silencer has a 3-in.-diameter perforated liner made of aluminized steel, fiberglass packing, and a pressure recovery cone at the outlet. Note that it was necessary to add a stock exhaust stack mast to accommodate the dual system.

As shown in Fig. 3, the enclosure is a tunnel-like structure leading from the radiator to the rear of the cab. As much of the existing cab and chassis structure as is practical is used to form this structure. Spaces between the cab and top of the frame rails are filled in with side shields and shelves, and a bellypan extends from one frame rail, under the engine and transmission, to the opposite frame rail.

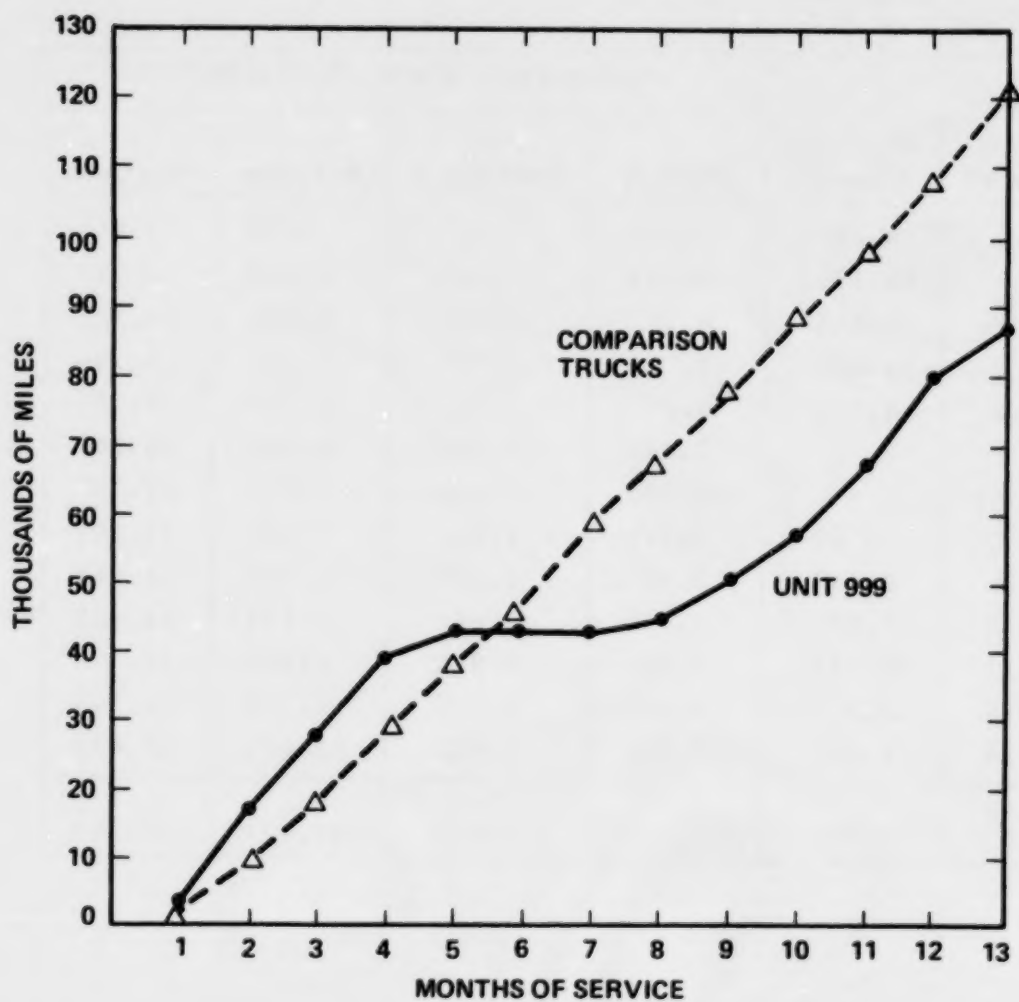
FIG. 9. COMPARATIVE MILEAGE.

A comparison of the Brigadier and the comparison trucks is shown in Table 6 and Fig. 9. The data show two distinct trends. When the Brigadier was in regular service it typically accumulated more mileage than the average comparison truck. However, the data also show that the quieted Brigadier accumulated significantly lower mileage in its yearlong test than the comparison trucks. The average comparison vehicle logged 121,433 miles in 13 calendar months. The quieted Brigadier logged only 86,865 miles, 28% below the average comparison truck. The lower overall mileage is attributable to the truck being out of service during much of early 1981. The quieted Brigadier was above average during the first five months, as shown in Fig. 9. However, it fell behind during the next few months, while the comparison trucks kept averaging 8,000 to 11,000 miles per month.

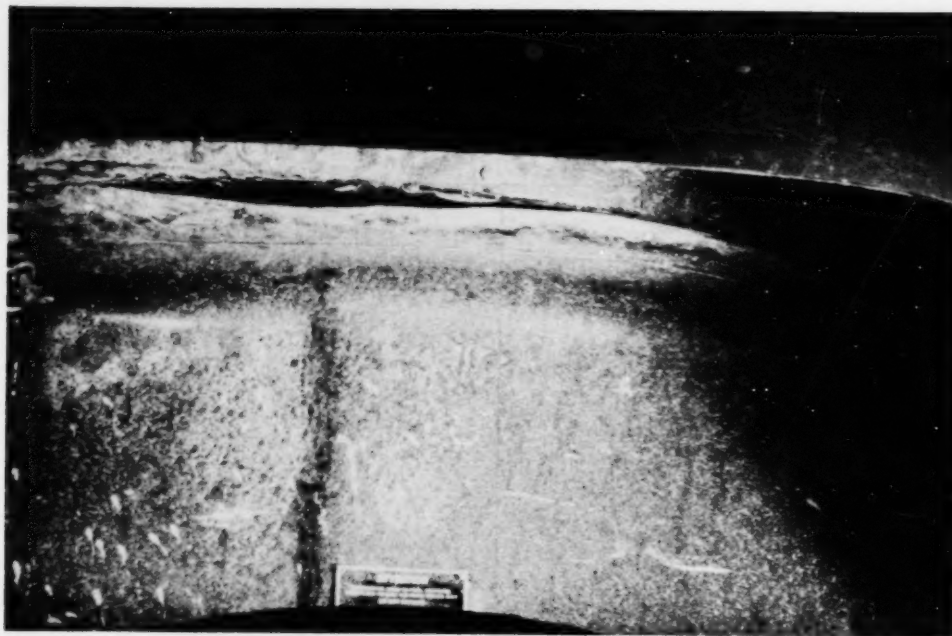
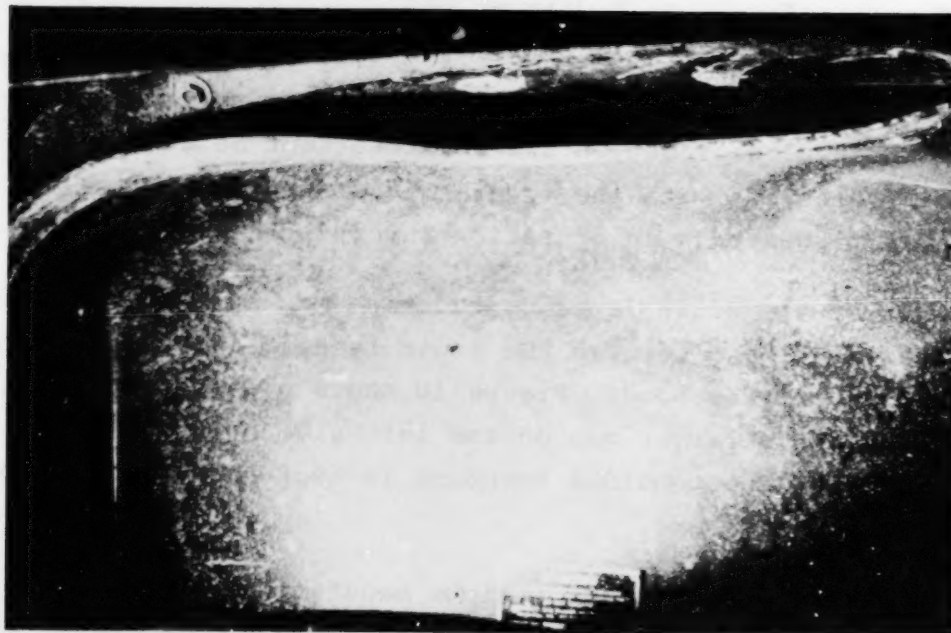
Part of the noise level degradation may be attributable to gaps that developed between the inner fenders and the corresponding portions of the hood. Figure 10 shows a small gap on the right side and a larger gap on the left side of the vehicle. Evidently, the sheet-molded compound is heat-sensitive and sags when sufficiently warm.

FIG. 10. GAPS THAT DEVELOPED BETWEEN INNER FENDERS AND HOOD ON BOTH SIDES OF VEHICLE.

Conversations with the vehicle manufacturer's technical staff indicate that inner fender sagging has been detected on other vehicles as well, and that solutions involving possible material or structural changes are under development. Since this project could not wait for these developments to be completed, we

reinforced each fender with two metal strips, as shown in Fig. 11. These strips held the fender firmly against the hood.

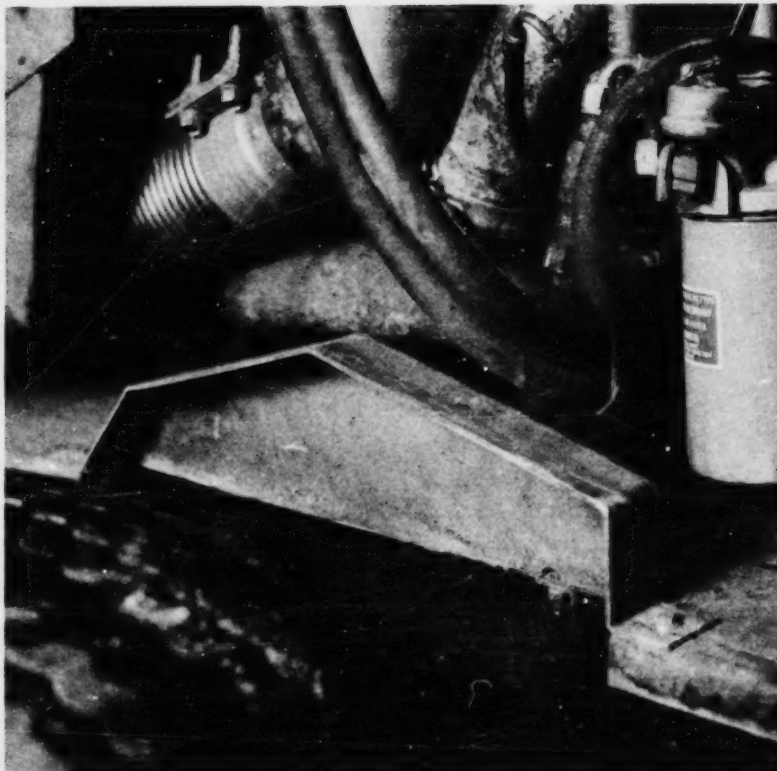
FIG. 14. REBUILT SHELF.

To prevent future contact between the shelf and bracket, the shelf was rebuilt as shown in Fig. 14. The contour was selected to match the contour of the original inner fender.

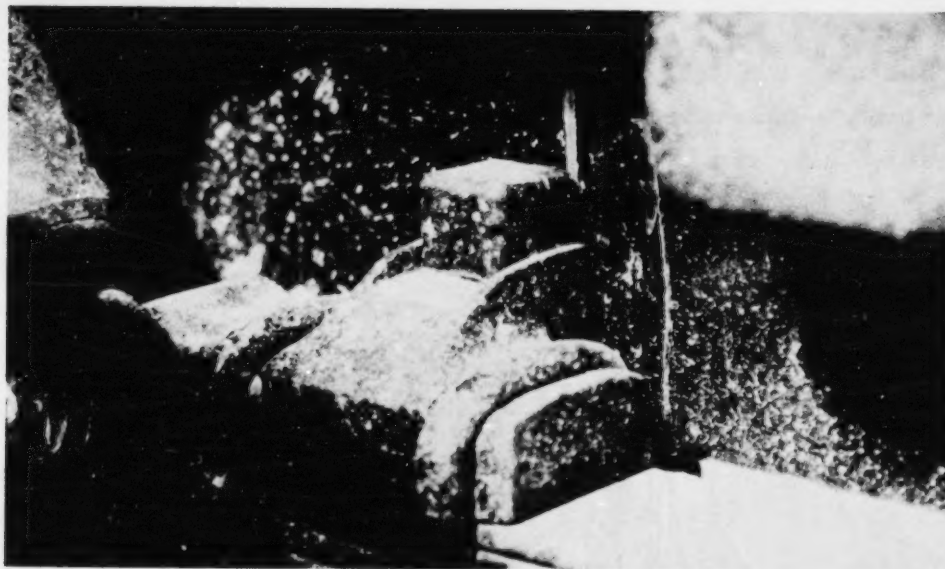
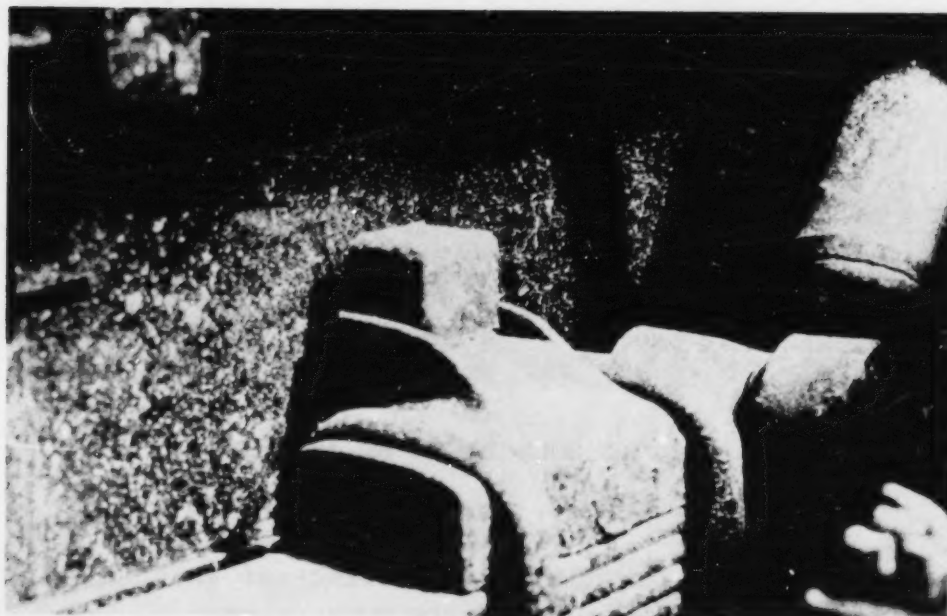
A minor clearance problem was detected between the front axle assembly and the right side of the bellypan (component R3 of Fig. 3). Figure 15a shows the gouge in the aluminum caused by the casting holding the rubber snubber and shock absorber. This casting is fastened to the front spring, which moves a lot as the vehicle chassis moves. Figure 15b shows that this problem did not occur on the left side of the vehicle. The problem was judged sufficiently minor that no corrective action was taken.

FIG. 15. RELATION OF SNUBBERS TO RIGHT AND LEFT SIDE PANELS OF BELLYPAN (R3 AND L3).

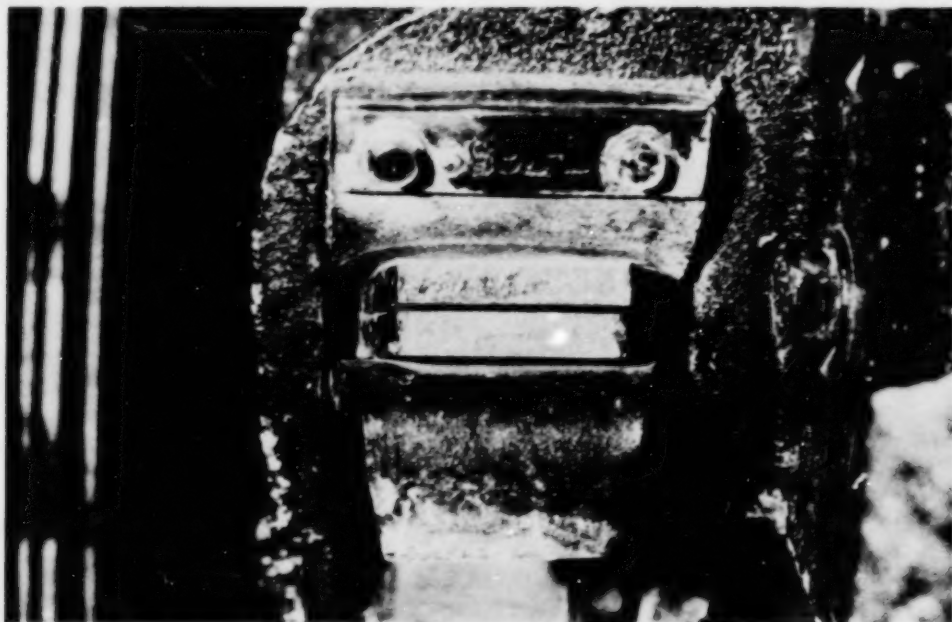
FIG. 18. BRACKET WELDED TO TEE CAN AND BOLTED TO FRAME CROSS MEMBER.

The exhaust system showed no signs of deterioration. The bracket welded to the Tee Can (see Fig. 18) retained its structural integrity and performed its function of supporting and keeping the exhaust line in place.

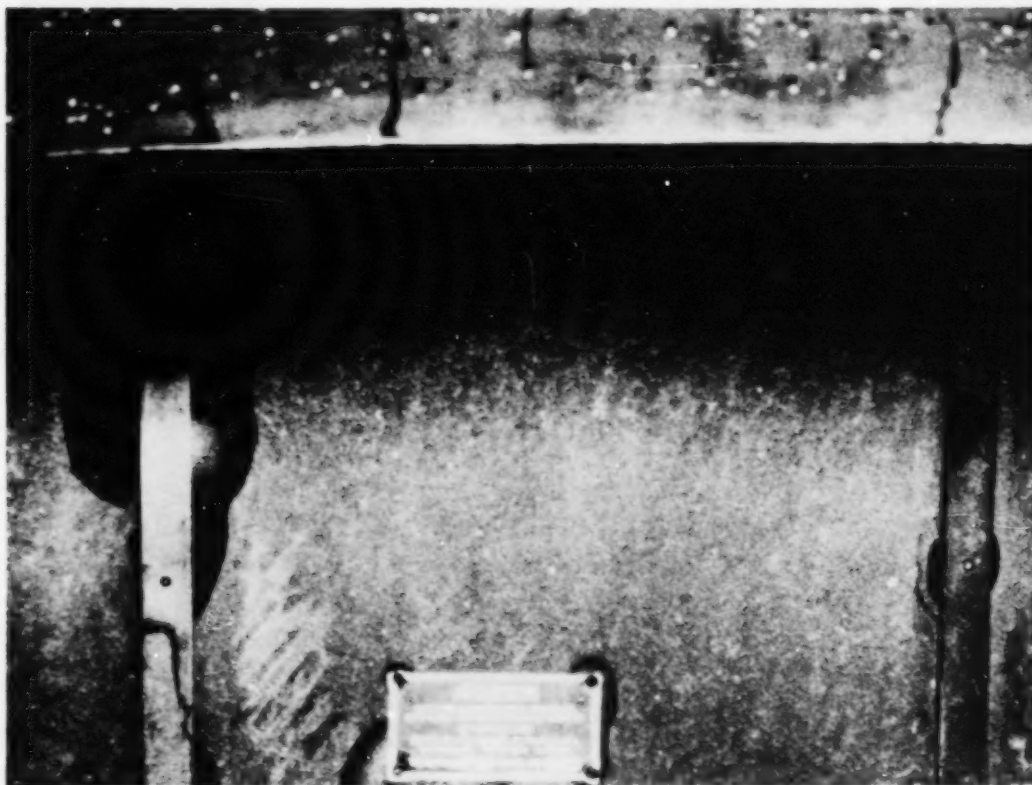
The reconfigured engine/transmission enclosure also proved durable for the most part during the last half of the operational test. Figure 20 shows that the seal between the inner fenders

FIG. 20. SEAL BETWEEN RIGHT INNER FENDER AND HOOD.

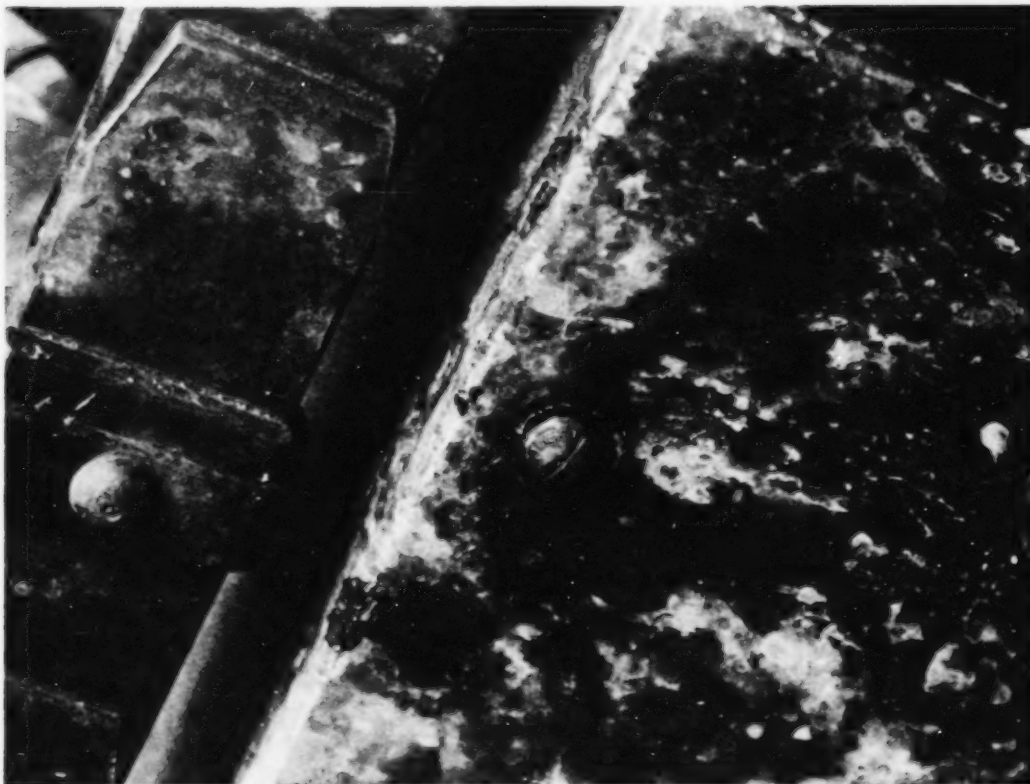
and hood remained tight. The reconstructed right side shelf (illustrated earlier in Fig. 14) showed no signs of wear. For the bellypan, the larger quarter-turn screw fasteners used to support the forward bottom pan, B1, retained their integrity, as shown in Fig. 21. However, the bail broke on one of the side latches used to support the intermediate bottom pan, B2, as shown in Fig. 22.

FIG. 21. QUARTER-TURN SCREW HEAD FASTENER USED TO HOLD FORWARD BOTTOM PAN (B1) IN PLACE.

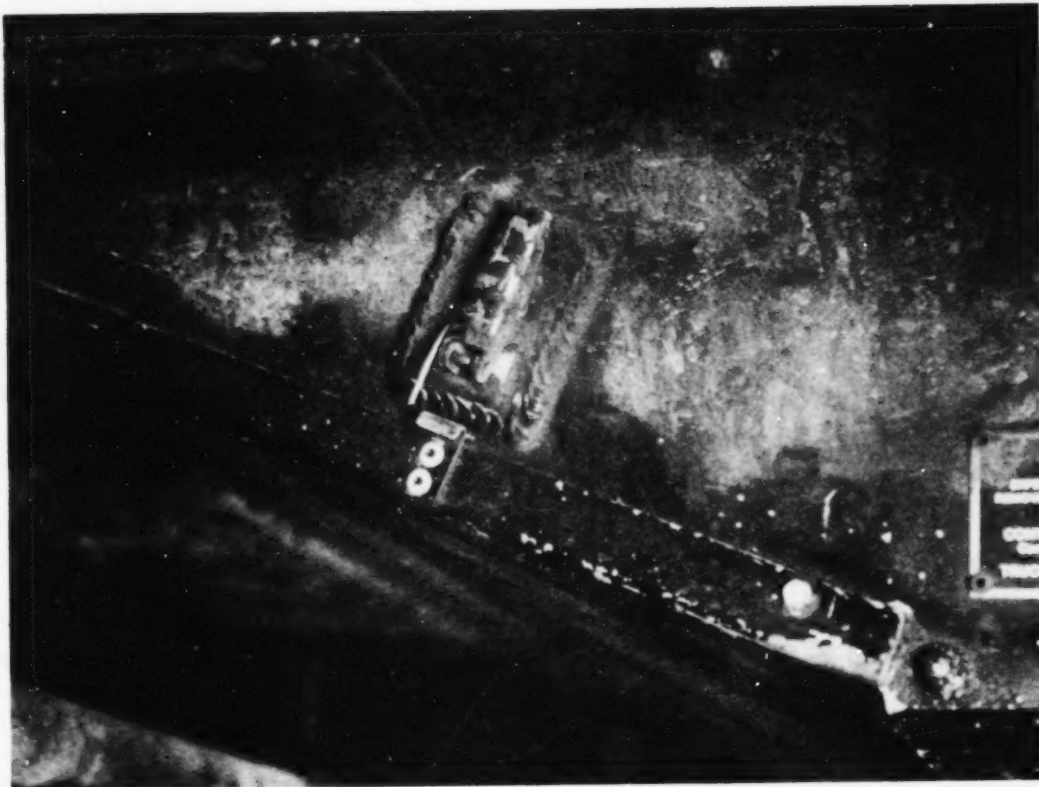
FIG. 22. BROKEN BAIL ON LATCH FASTENER USED TO SUPPORT INTER-MEDIATE BOTTOM PAN (B2).

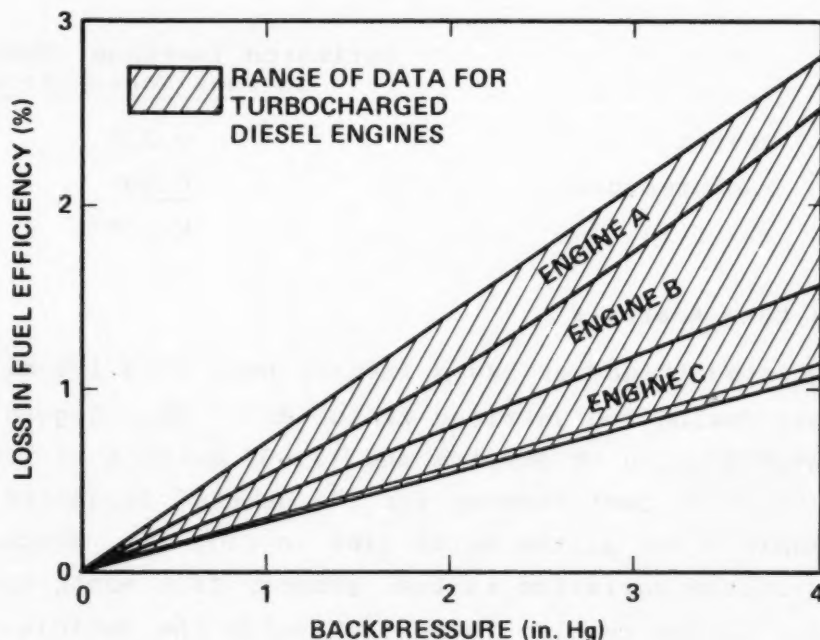
FIG. 23. RELATIONSHIP OF DIESEL ENGINE FUEL EFFICIENCY TO EXHAUST BACKPRESSURE.

To estimate the effect of backpressure, consider the relationships between fuel efficiency and backpressure illustrated in Fig. 23. The shaded area corresponds to a published composite of data [7], while the three curves within this area are for proprietary data supplied to BBN by several engine manufacturers. Reference 7 suggests that, for turbocharged diesel engines, fuel economy improves by an average rate of 0.5% per inch of mercury decrease in backpressure. This number is consistent with the data in Fig. 23 and will be used for our estimates.

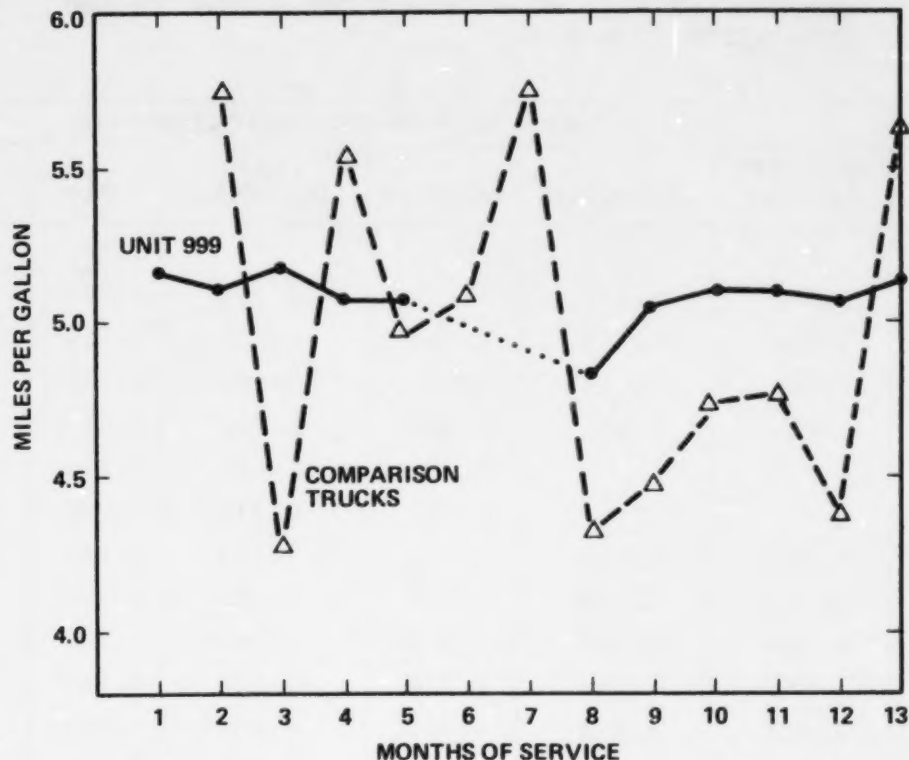
FIG. 24. COMPARATIVE FUEL ECONOMY.

The quieted Brigadier had a fuel economy of 5.109 miles per gallon (mpg) during the yearlong field test. This figure is based on 86,865 miles of service and 17,003 gallons of fuel. The monthly pattern of fuel economy for the quieted Brigadier is shown in Table 9 and as the solid line in Fig. 24. There was relatively little variation in fuel economy from month to month, both because of the regular route over which the vehicle operated and the small variation in payload. Monthly fuel economy ranged from a low of 4.834 mpg to a high of 5.240 mpg.

Table 9 and Fig. 24 also present fuel economy data for the comparison trucks. These trucks had lower fuel economy - 4.939 mpg vs 5.109 for the quieted Brigadier. The month-to-month variation for the comparison trucks was also much greater than the Brigadier's. Fuel economy ranged from 4.313 to 5.741 mpg. This probably reflects variation in payloads, terrain, and weather condition, since the comparison trucks operated throughout the entire ABF system.

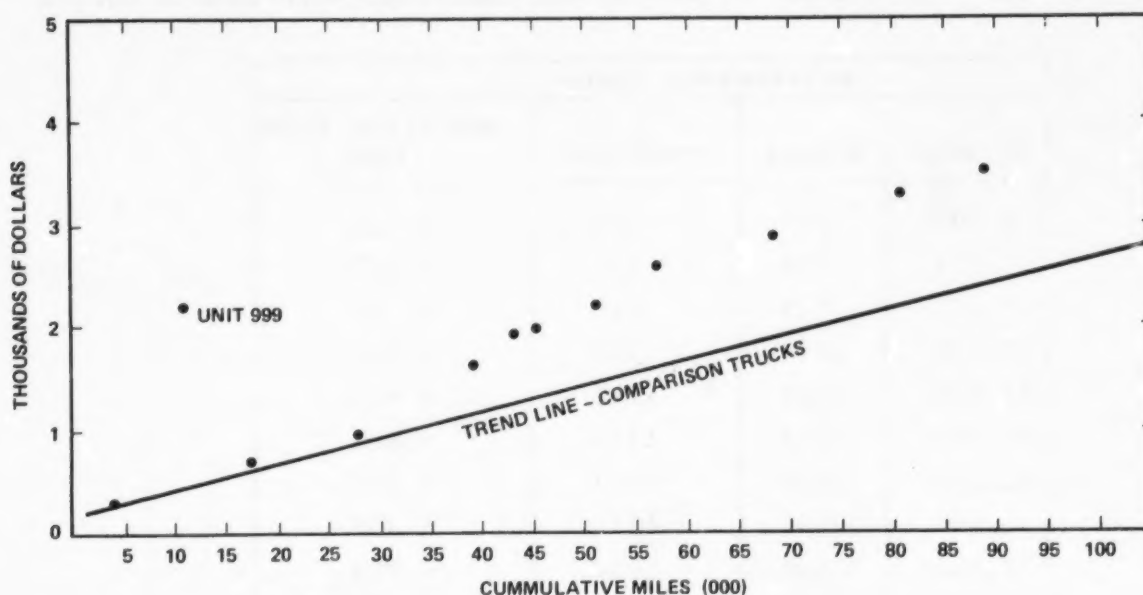
FIG. 30. COMPARATIVE MAINTENANCE COSTS.

The regression line derived from this equation is shown as the solid line in Fig. 30. The actual maintenance costs for Unit 999 are shown as solid dots in Fig. 30. As is evident from the Figure, Unit 999's maintenance costs are above the trend line for the comparison trucks. The extent of the deviation is summarized

in Table 13. Unit 999's maintenance costs are 46% above the fleet trend based on 86,865 miles of fleet service.
